ENGINEERING CONDITION SURVEY AND
EVALUATION OF TROY LOCK AND DAM
HUDSON RIVER, NEW YORK

ENGINEERING CONDITION SURVEY,

Carl E. Pace

May 1978

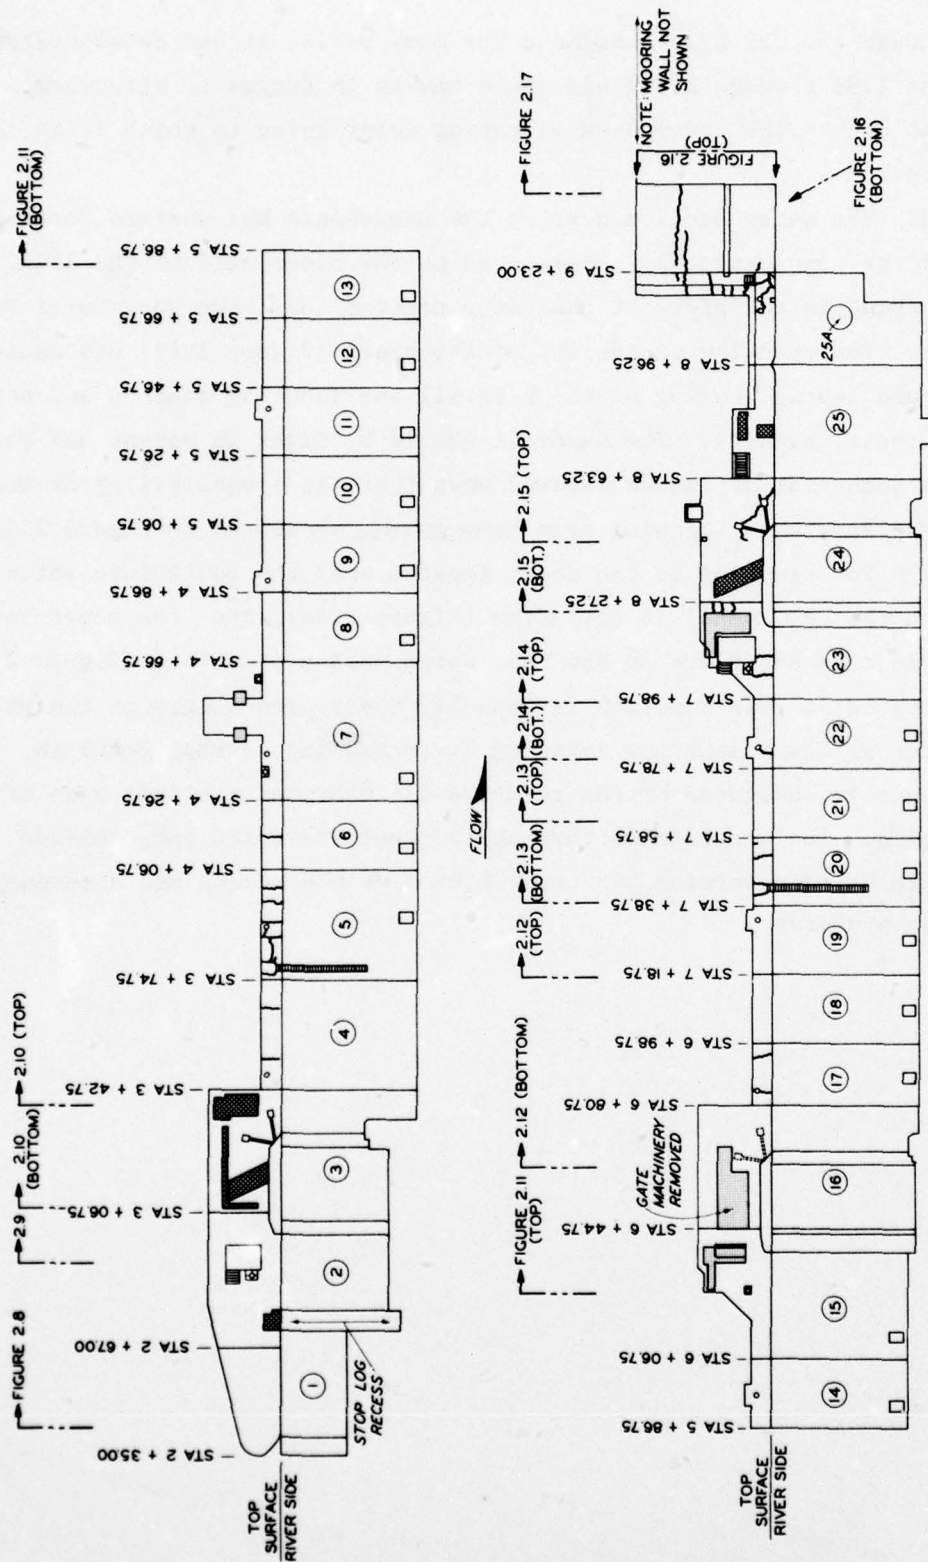
Figure 2.1 Surface cracks, landwall, Troy Lock and Dam, Troy, New York.

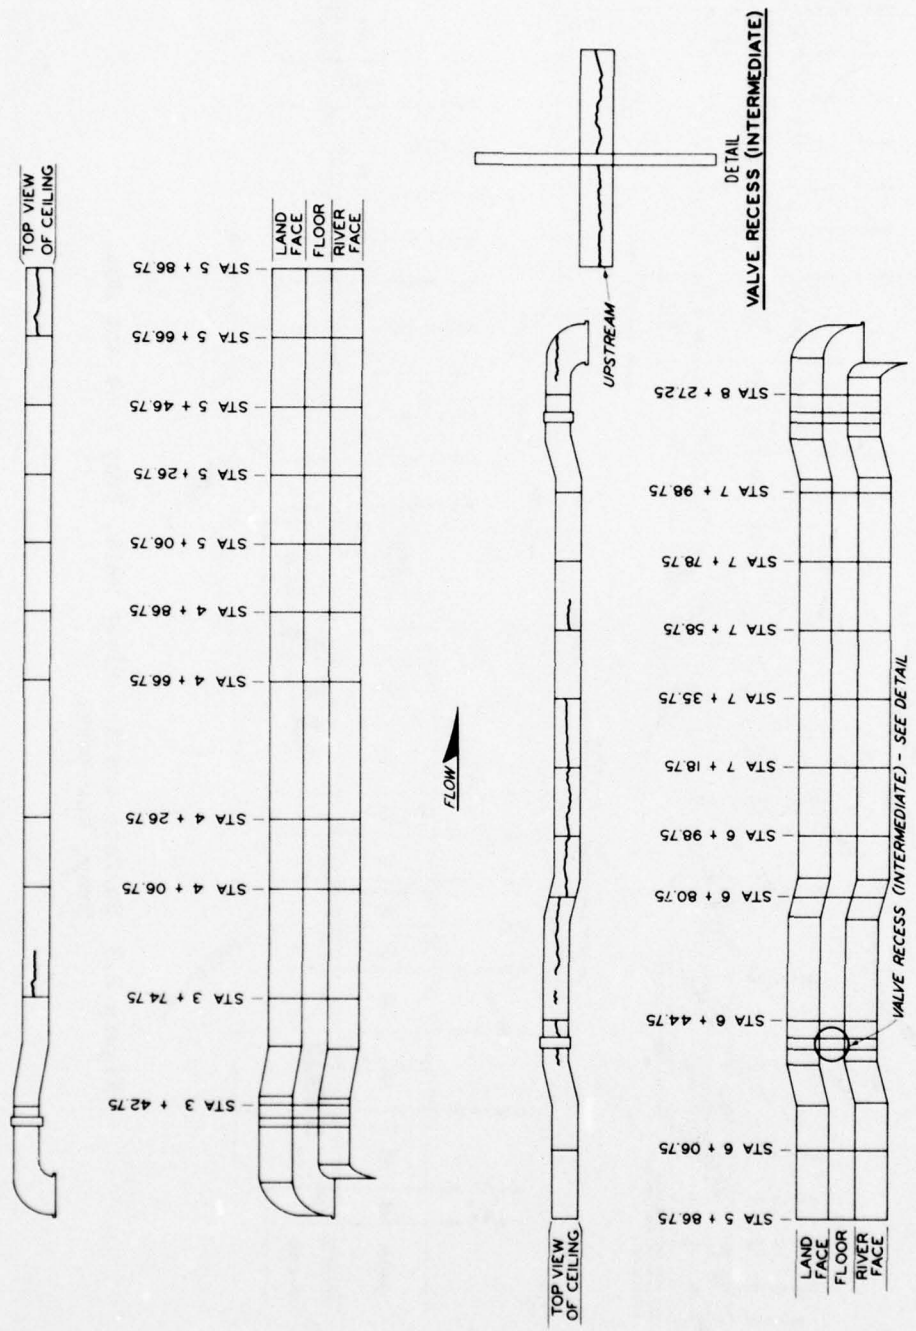
Figure 2.2 Surface cracks, landwall filling and emptying culvert, Troy Lock and Dam, Troy, New York.

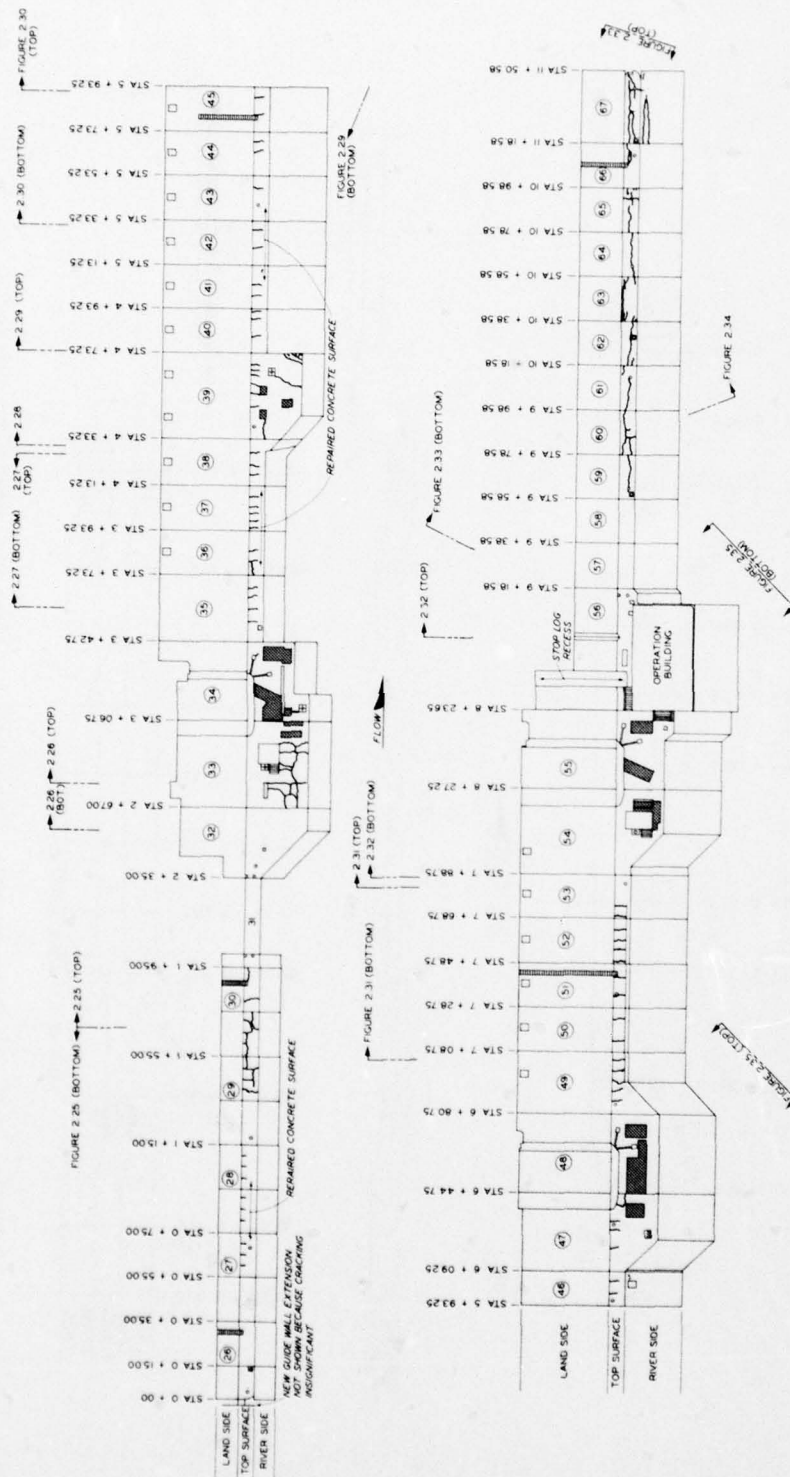
Figure 2.3 Surface cracks, river wall, Troy Lock and Dam, Troy, New York.

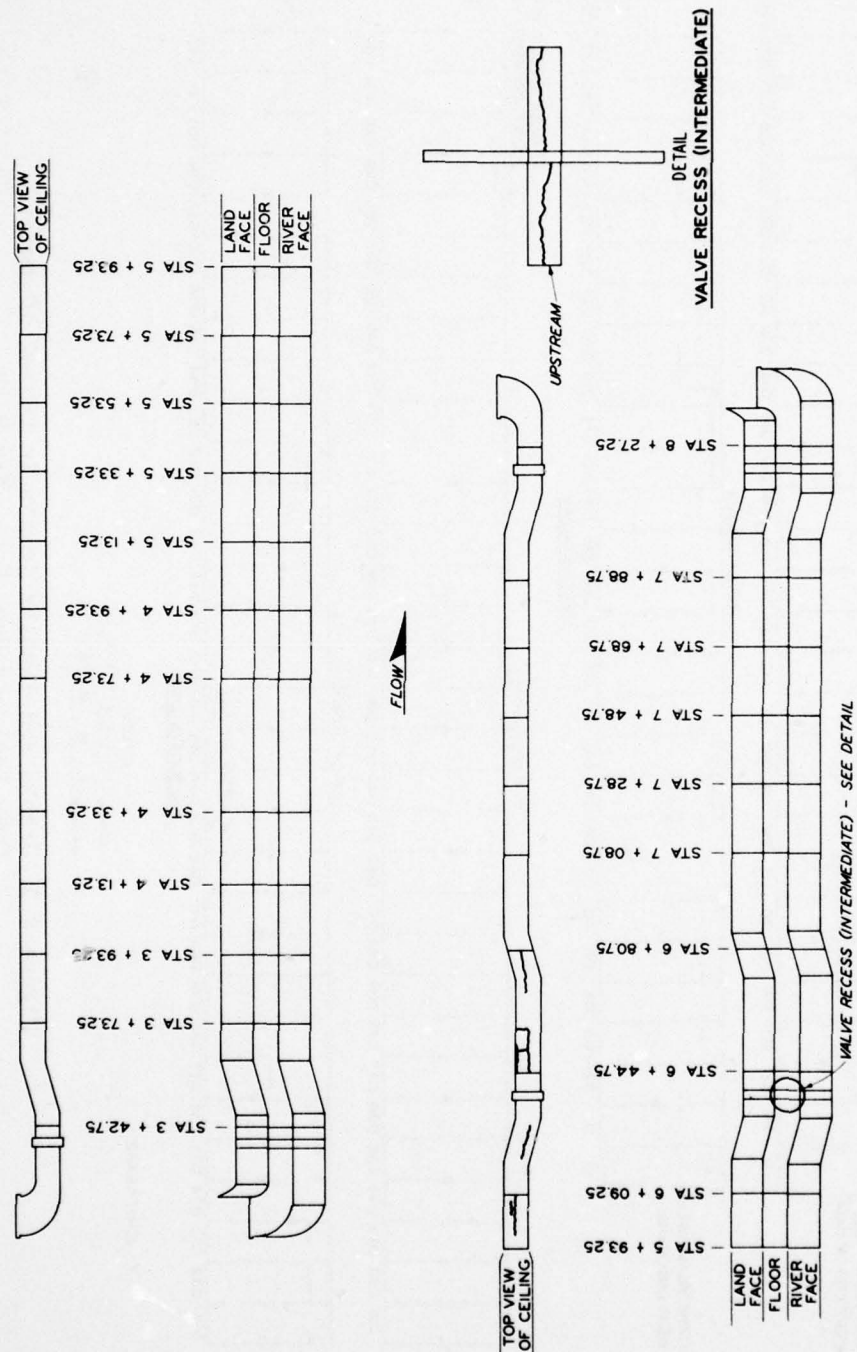
Figure 2.4 Surface cracks, river wall supply tunnel, Troy Lock and Dam, Troy, New York.

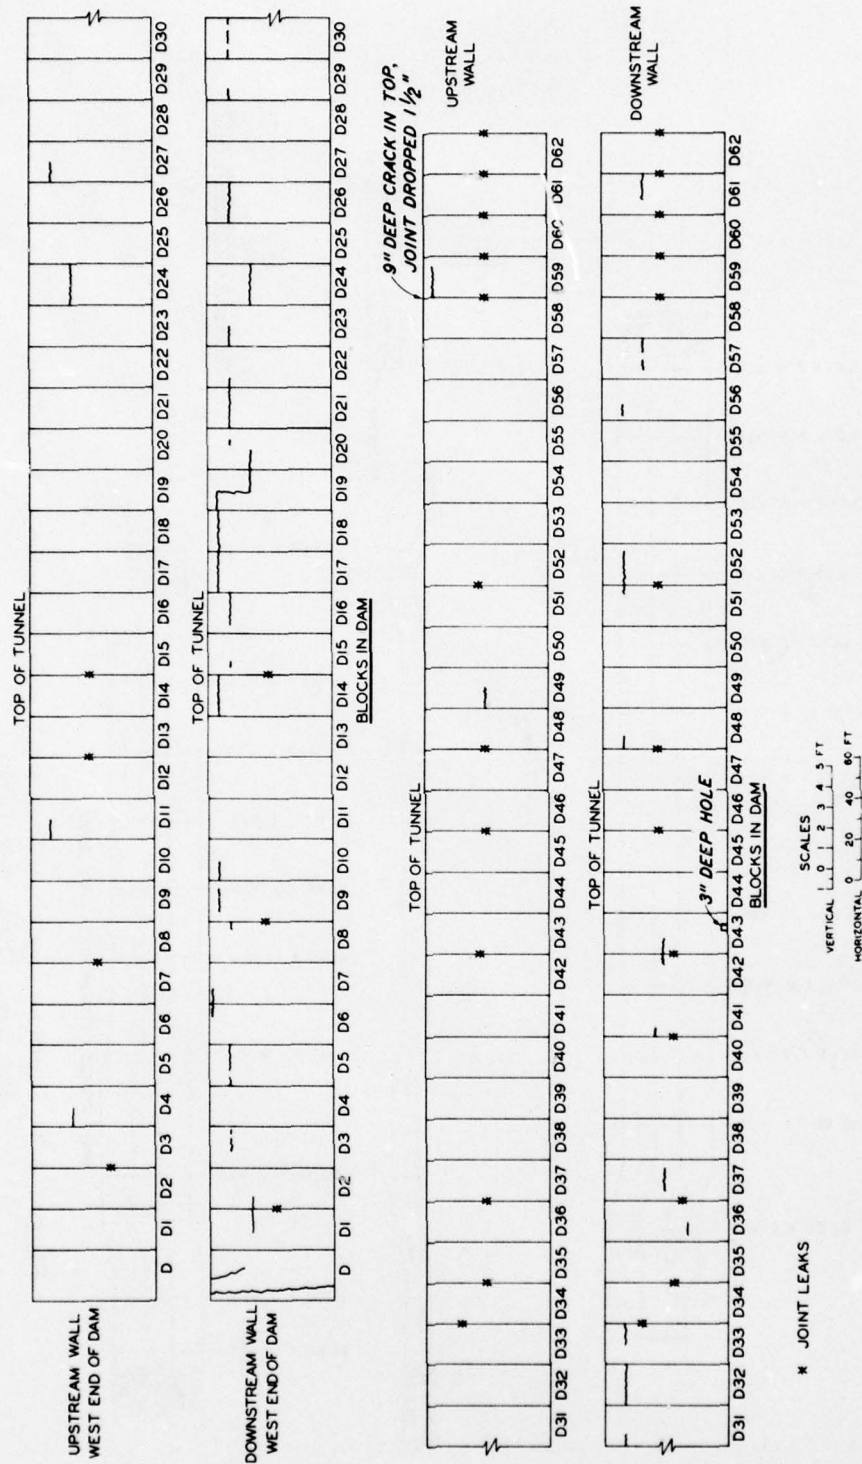
35. Figure 2.37 shows leaking construction joints in the dam tunnel. Figure 2.5 indicates the construction joints which are leaking. The dam is not cracked severely but there is a heavy vibration of the dam monoliths due to the force of water flowing over its top and downstream to the stilling basin. The vibration frequency and displacement should be monitored and applied as input and the response of a dam monolith evaluated.

Figure 2.5 Cracks and leaking joints in tunnel of dam, Troy Lock and Dam, Troy, New York.

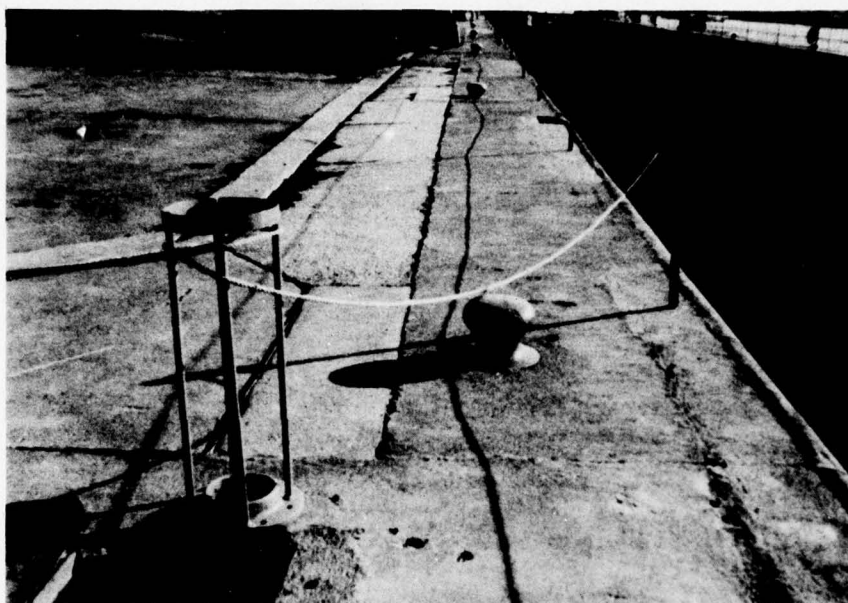
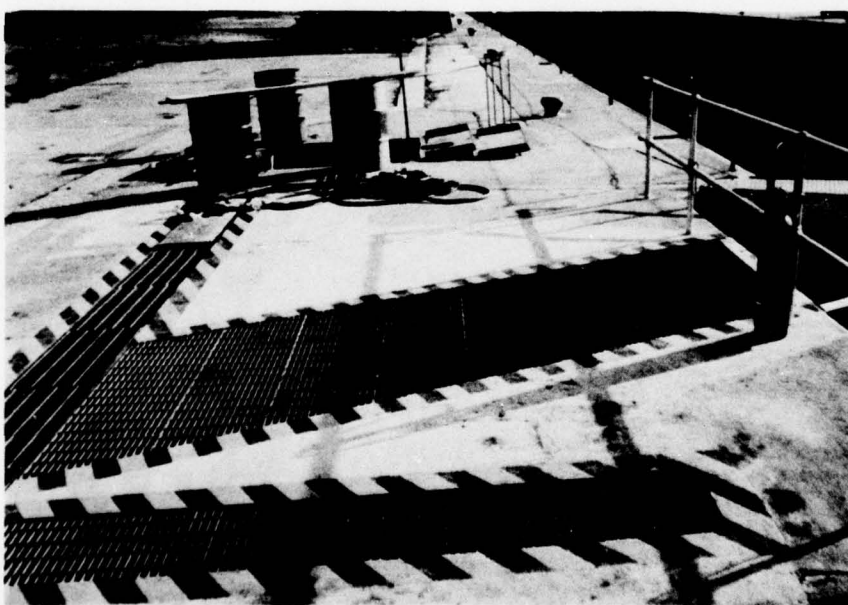
26. As will be discussed later, the construction joints are a major problem at this lock and dam and will have to be sealed to alleviate future deterioration and, hence, structural and operating problems. In Figure 2.10 the vertical construction joint (which can be seen at the back of the lock wall, upper view) has water gushing from it when the lock chamber is almost full due to pressure head in the filling and emptying culverts. This signifies an open construction joint or crack which must be sealed.

Figure 2.10 Landwall--view just upstream (bottom), then downstream (top) of upper miter gate.

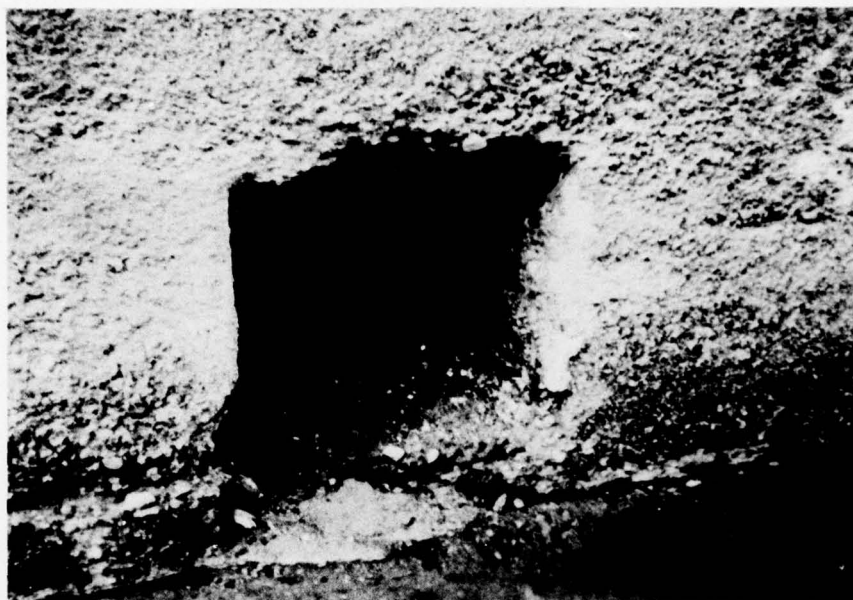
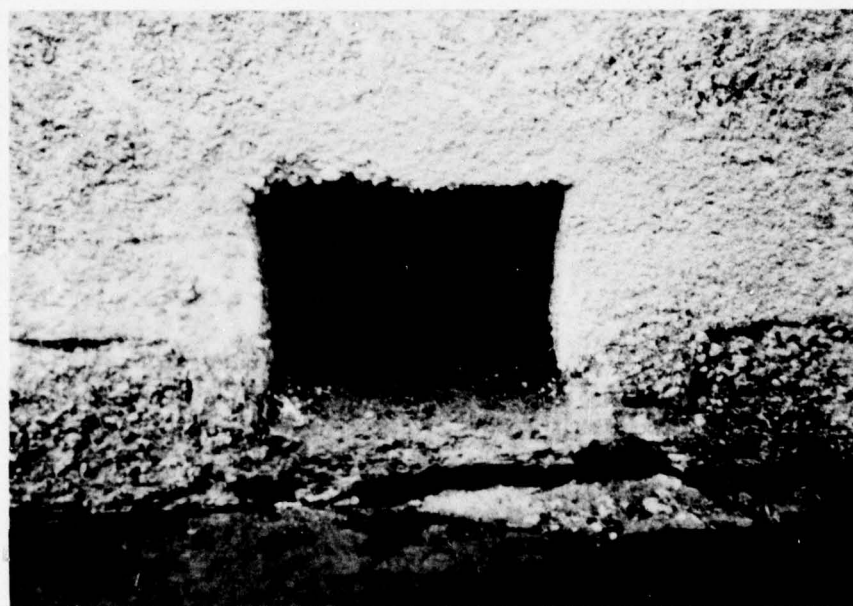
28. The filling and emptying ports in both the land and river walls are deteriorated (see Figure 2.20) and are in need of repair at the face of the lock wall. The majority of the ports are in this condition and only typical ones are presented in Figure 2.20. Each port will need to be evaluated independently as it is repaired.

Figure 2.20 Typical view of filling and emptying ports.

6. Undercutting of concrete at filling and emptying ports.	Repair, specifics to be determined in Phase II work.	Same as for deficiency No. 4.	
	7. Concrete removal on the vertical wearing surface of guide guard, and lock wall.	After coring decide on: a. Replacement of specific depth of deteriorated concrete and placement of wall armor. b. Place protective wall armor on walls.	Same as for deficiency No. 4.

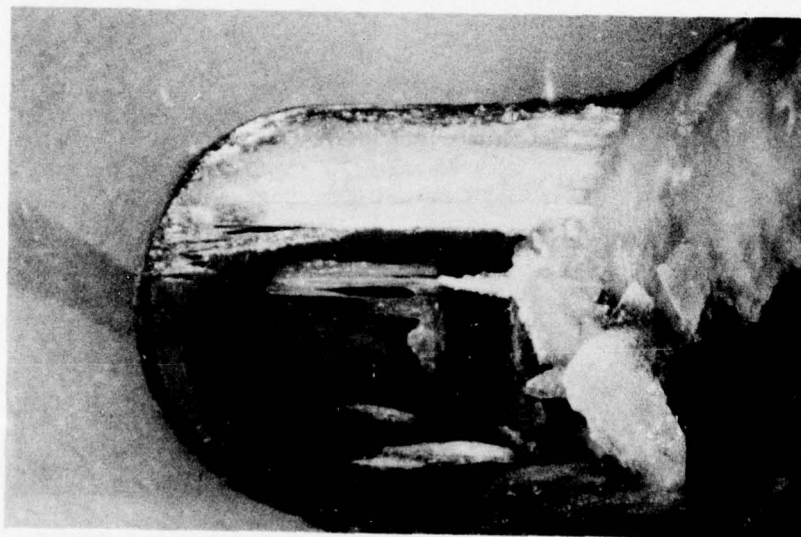
Figure 2.21 Typical view of construction joint leakage in riverwall filling and emptying culverts as portrayed by ice sheets.

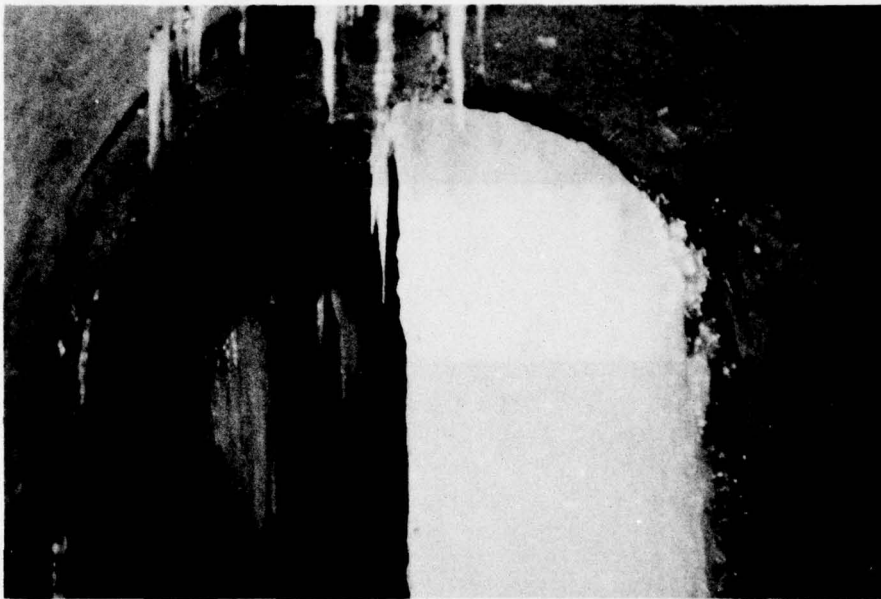
Figure 2.22 Typical view of construction joint leakage in landwall filling and emptying culverts as portrayed by ice sheets.

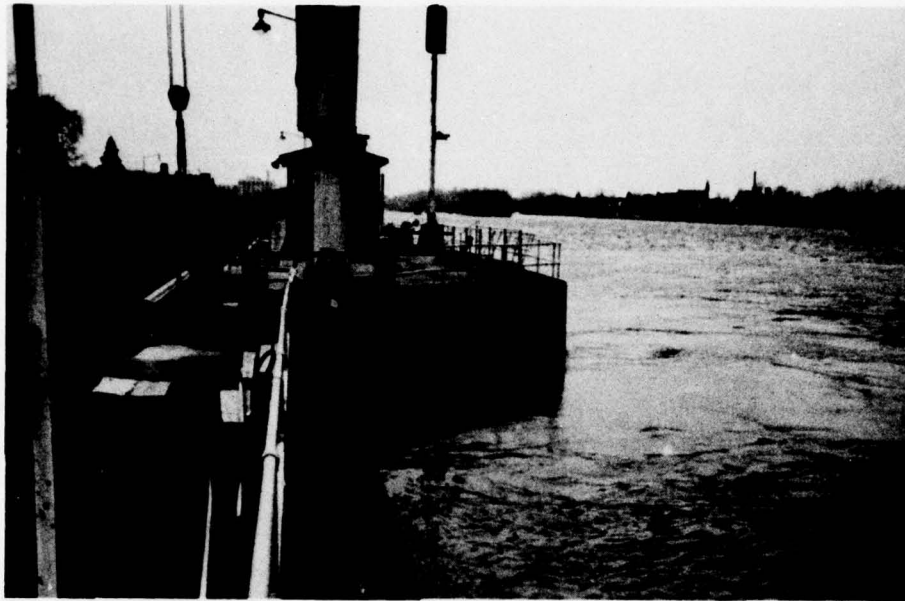
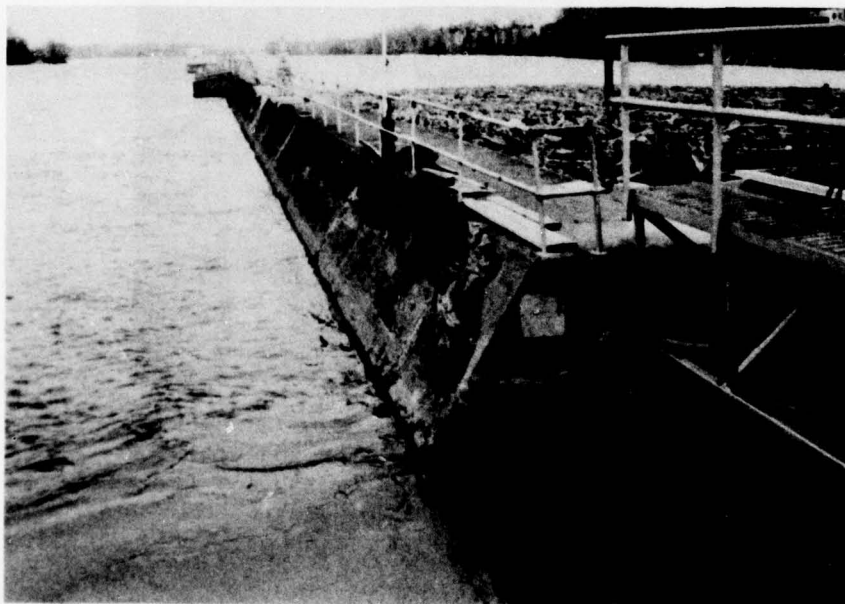
32. Figure 2.25 (bottom) is viewing the original and newer guide wall in an upstream direction. The new guide wall extension is in good condition. The original guide wall has bad surface deterioration but it is not cracked extensively. Figure 2.25 (top) is viewing the river wall from upstream to downstream. The surface deterioration is severe and there needs to be some maintenance of this surface to prolong the life of this lock and dam, thereby moving toward economy in navigation along the Hudson River. Figure 2.26 shows deterioration in front of the first operation station upstream of the upper miter gate. To the side of the operation station we see the lock surface toward where the dam joins the lock wall; it has been repaired. At the intersection of the dam to the lock (Figure 2.28), there is a lot of surface deterioration. In Figures 2.29 through 2.32 we see further down the lock on the river side; there is a lot of surface concrete deterioration.

Figure 2.25 Original and newer guide wall looking upstream (bottom) to downstream view of beginning of riverwall (top).

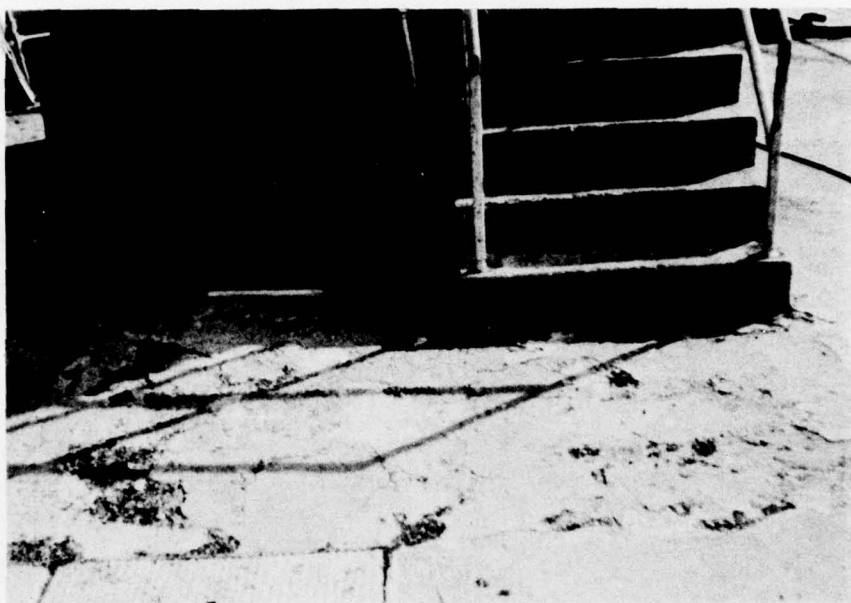
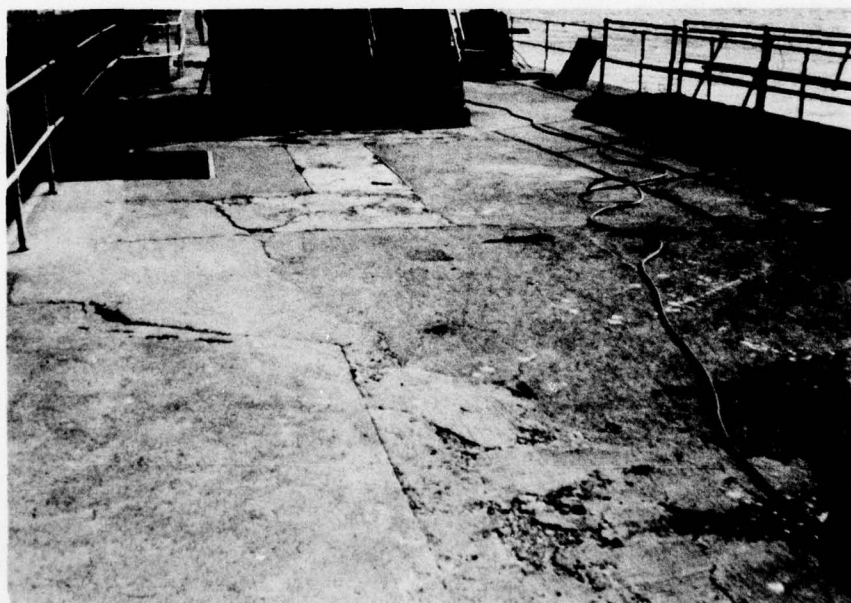
Figure 2.26 Riverwall--surface concrete deterioration at the first operating station upstream of upper miter gate.

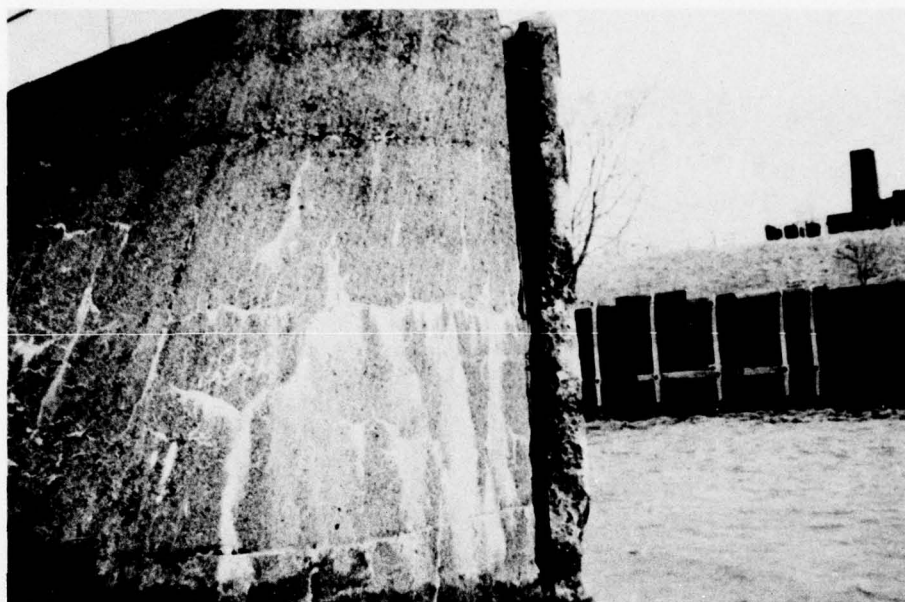
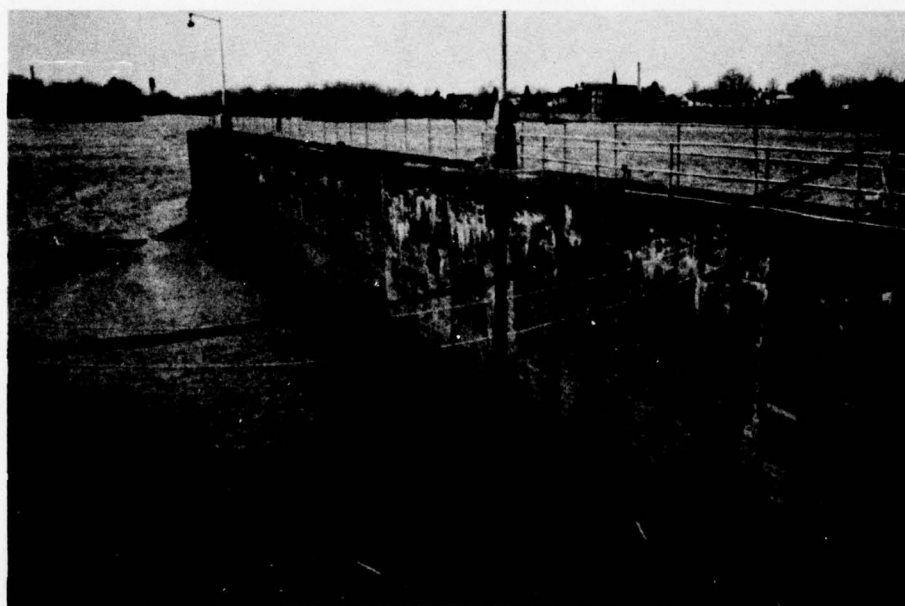
33. The deterioration of the upper guide wall is consistent with that of the river wall and is in great need of maintenance. Figure 2.33 shows the downstream end of the downstream guide wall. The deteriorated river side of the guide wall is seen in Figure 2.34. The reduction in section of the supporting walls of the operating building is shown in Figure 2.35 (bottom).

Figure 2.33 Downstream guard wall--landside (bottom)
and downstream nose (top).

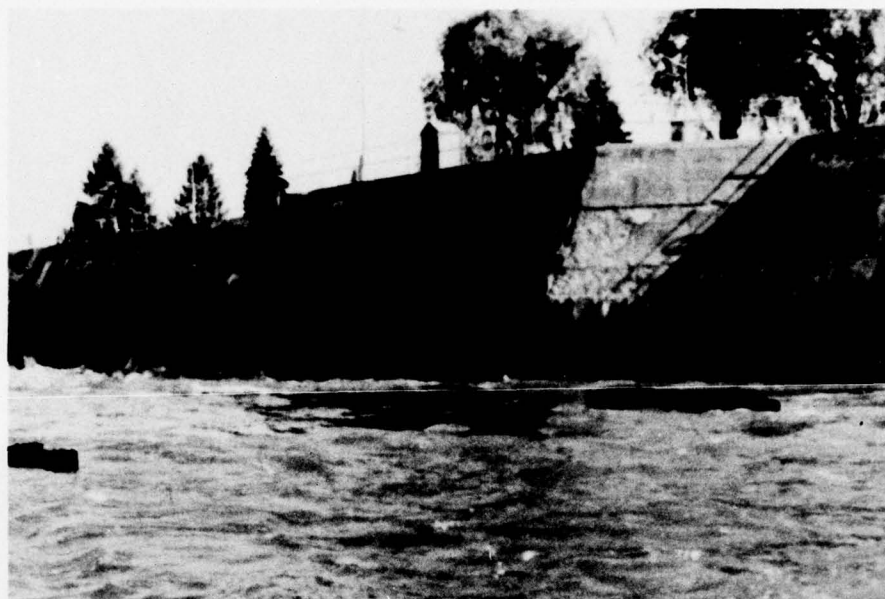
34. There is also a lot of undercutting or section reduction at the region of normal tidal fluxion (Figure 2.35 (top) and Figure 2.36). There is also water flowing out of a construction joint in the lock wall from the power tunnel into the river (Figure 2.35 (top) and Figure 2.36). The power tunnel could not be inspected, but dye was placed in its upstream end and was observed to flow through this construction joint.

Figure 2.35 Reduction in section of operation building (bottom) and riverside riverwall (top). Water flow through construction joint of riverwall (top).

5. Undercutting at level of main tidal fluctuation in base of main control house and in river wall monoliths.	Repair, specifics to be determined in Phase II work.	Same as for deficiency No. 4.

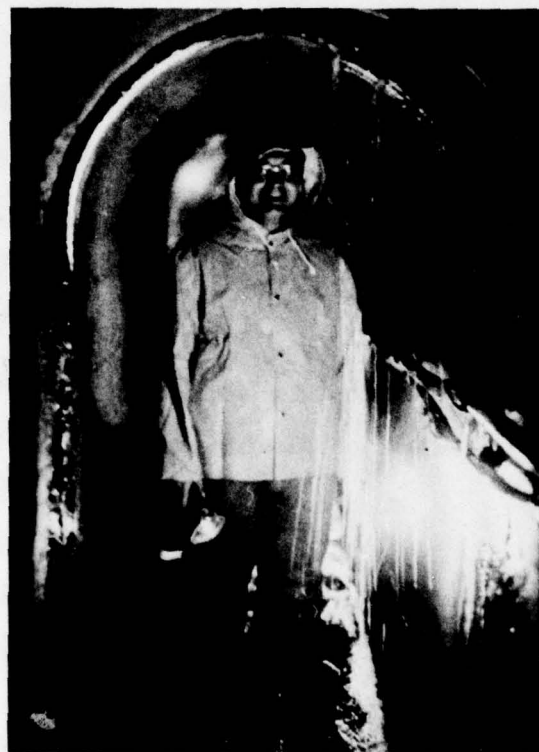
Figure 2.37 Leaking construction joints in dam tunnel.

9. Deteriorated construction joints.	Seal with chemical grout, quick-setting, shrinkage-compensating portland cement grout or by drilled holes packed with asphalt sealer.	None.

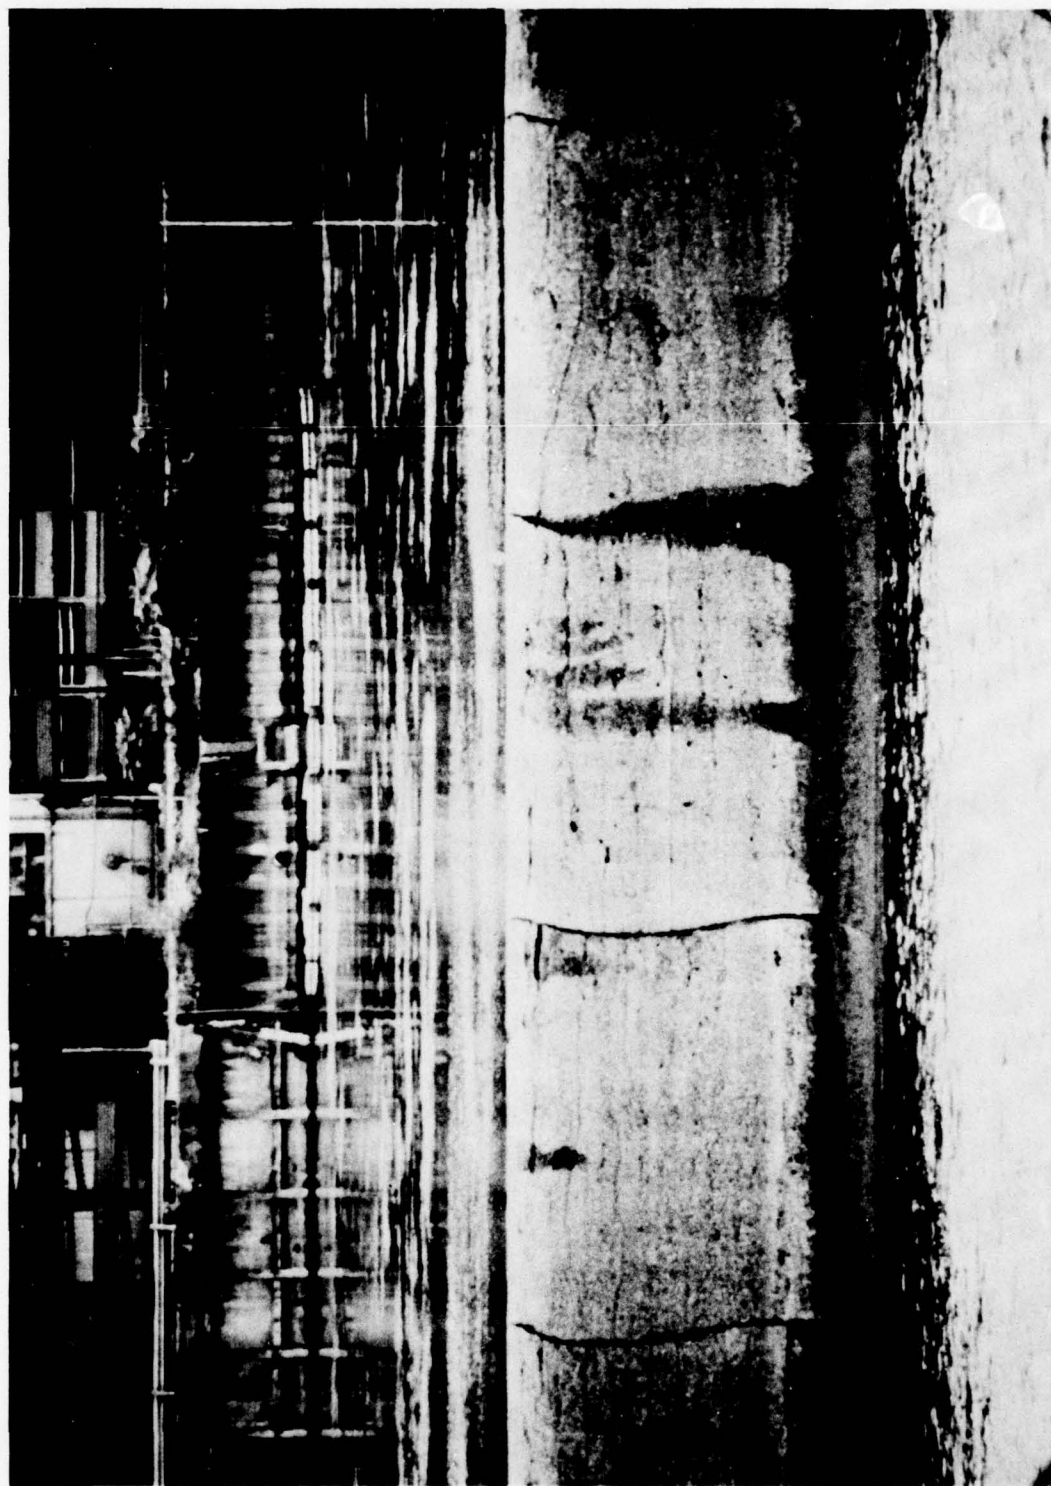
Even though the dam has functioned for many years, it has deteriorated (Figures 2.38 through 2.41) and could now be in danger of structural problems due to the tremendous vibrating water force to which it is subjected.

Figure 2.38 Deterioration of dam monoliths (D23, D24, and D25).

10. Deteriorated surface concrete.	Prepare and epoxy the eroded surface.	Core to determine depth and extent of deterioration.
	11. Surface contact of dam monoliths with foundation.	To be determined.	Core to determine this contact.

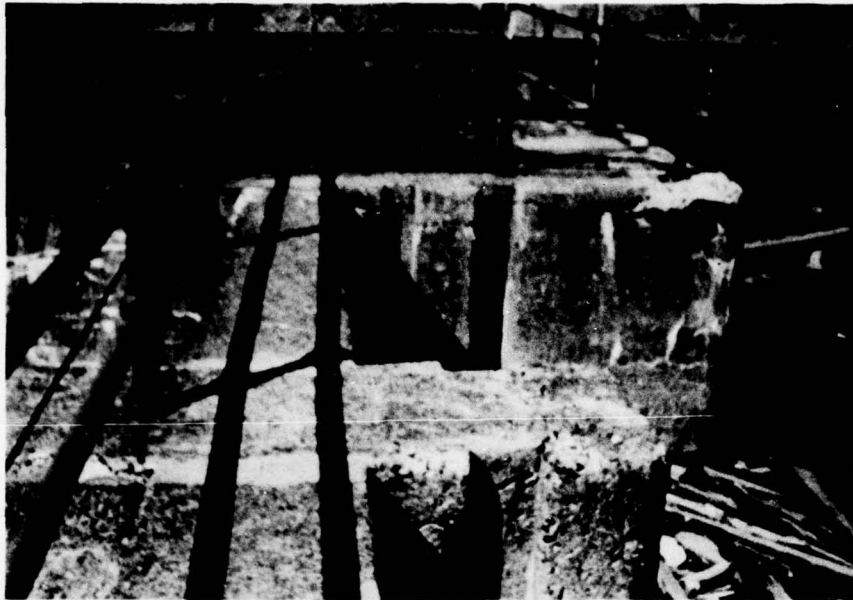
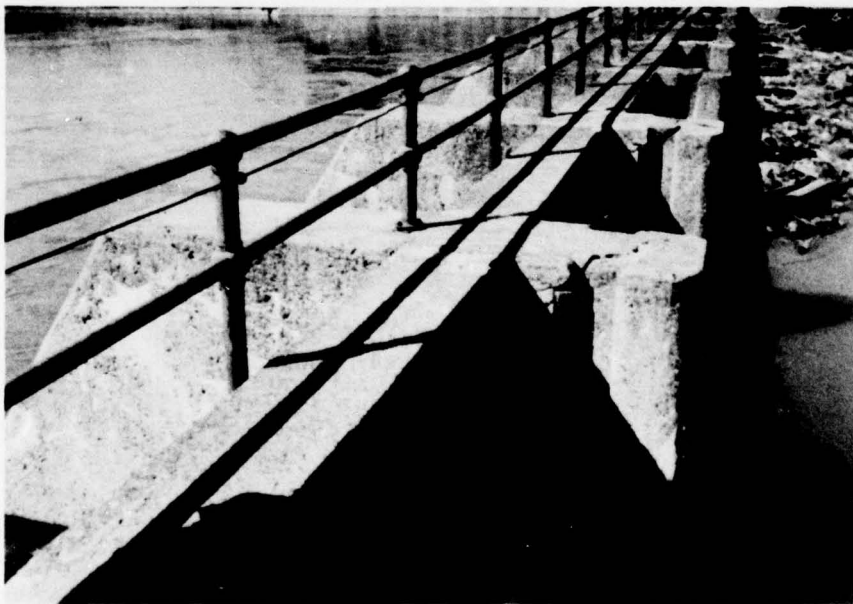
36. The gated section next to the powerhouse has surface deterioration of the same degree as experienced on the river wall of the lock. The cracking in the piers of the gated section does have structural implications. The cracking in the top of the piers (Figure 2.42) was caused by ice and debris lodging on the handrail and inducing moments and stresses beyond their capacity. The handrail should be light in weight and removable such that it can be removed when there is a possibility of ice or debris lodging. Leaching from these piers is presented in Figure 2.43.

Figure 2.42 Cracking and deteriorated surface concrete in the piers of the gated section near powerhouse.

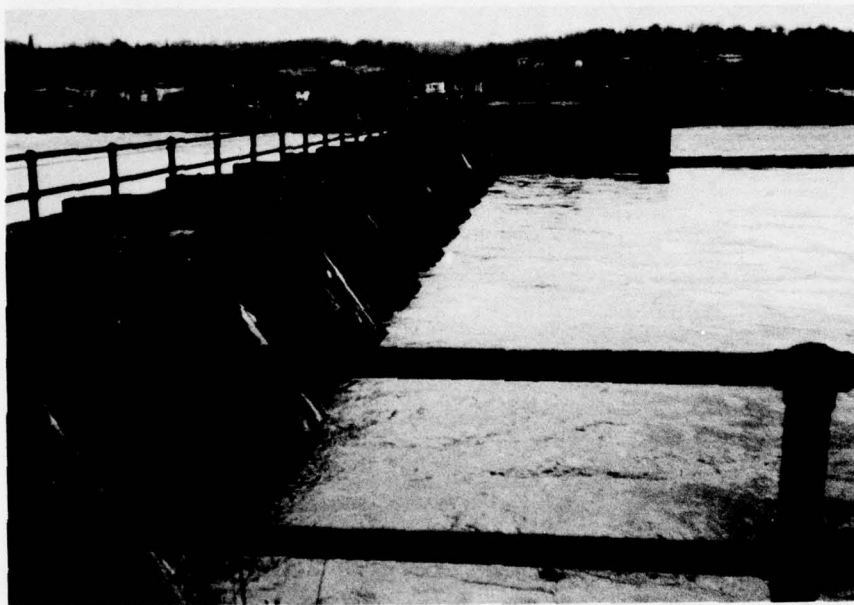
Figure 2.43 Leaching in piers of gated section near powerhouse.

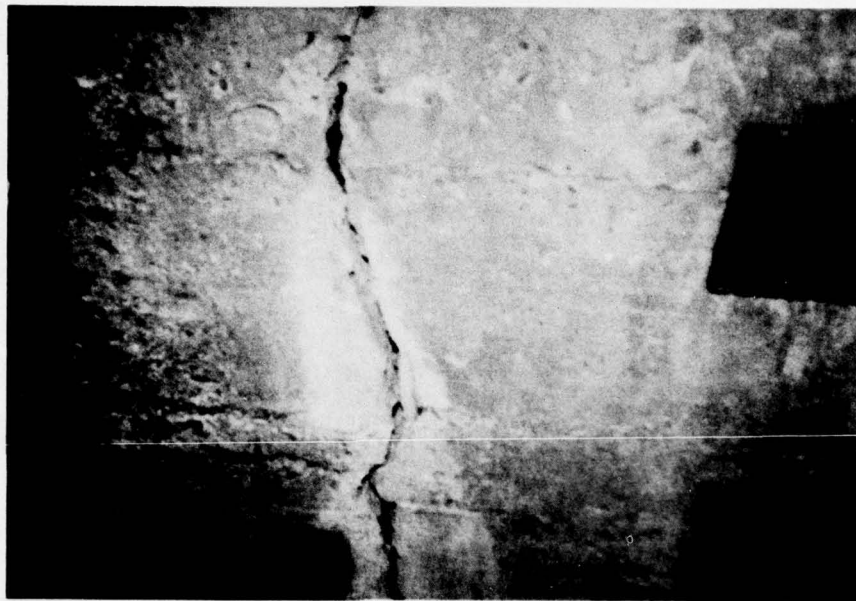
37. The cracking in the shaft located near the powerhouse which leads to the dam tunnel is extensive (Figure 2.44), and the construction joints in this shaft are so bad that water gushes from them (Figure 2.45). The cracking in this monolith is probably due to ice lodging on the weir and gated spillway sections inducing overstressing in this monolith. This cause is indicated by the relative dislocation at either side of the cracks. The monolith at this shaft should be cored and analyzed structurally to determine the significance of the cracks and necessary remedial measures.

Figure 2.44 Cracking in the shaft which allows entrance to the dam tunnel.

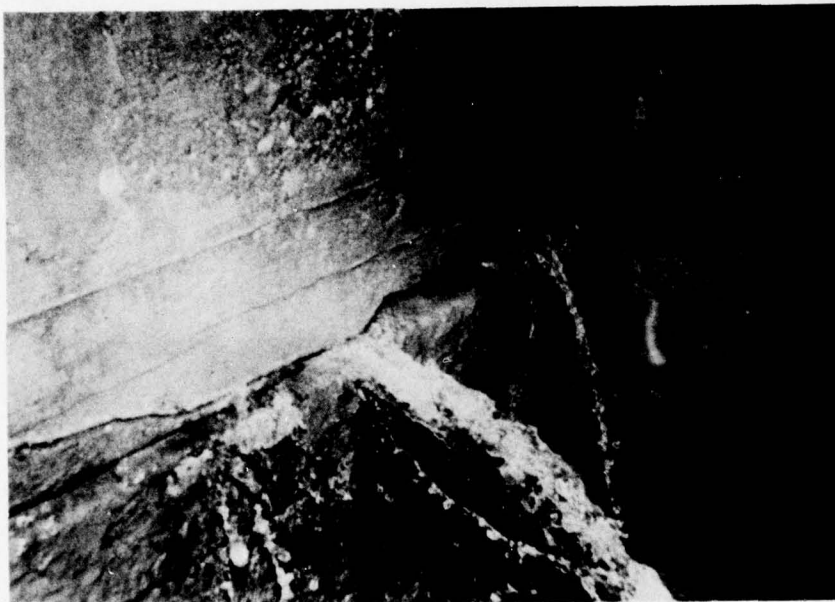
Figure 2.45 Leaking construction joint in the shaft which allows entrance into the dam tunnel.
